SERVICE BULLETIN

EQUIPMENT SERIES: 32S

BULLETIN NO. 4A

SUBJECT: TO IMPROVE CW OPERATION

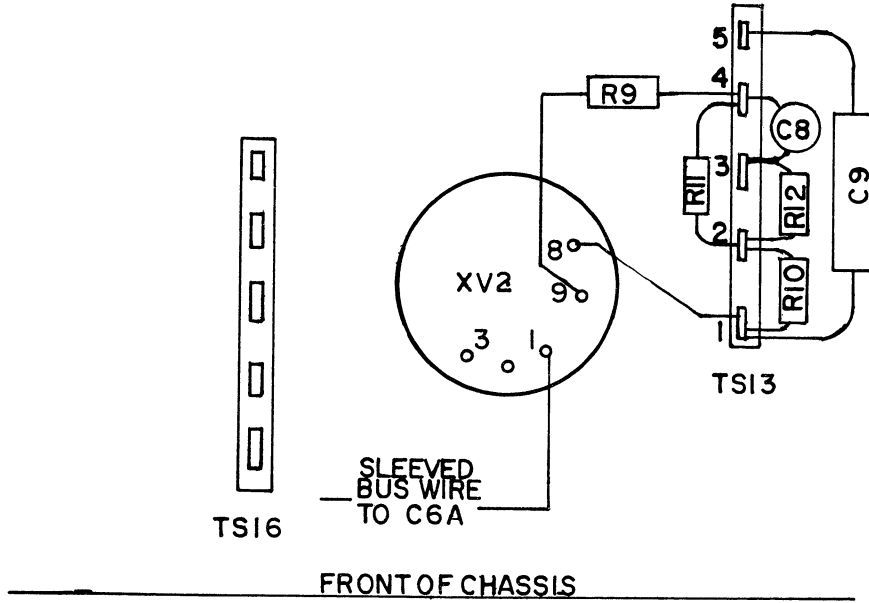
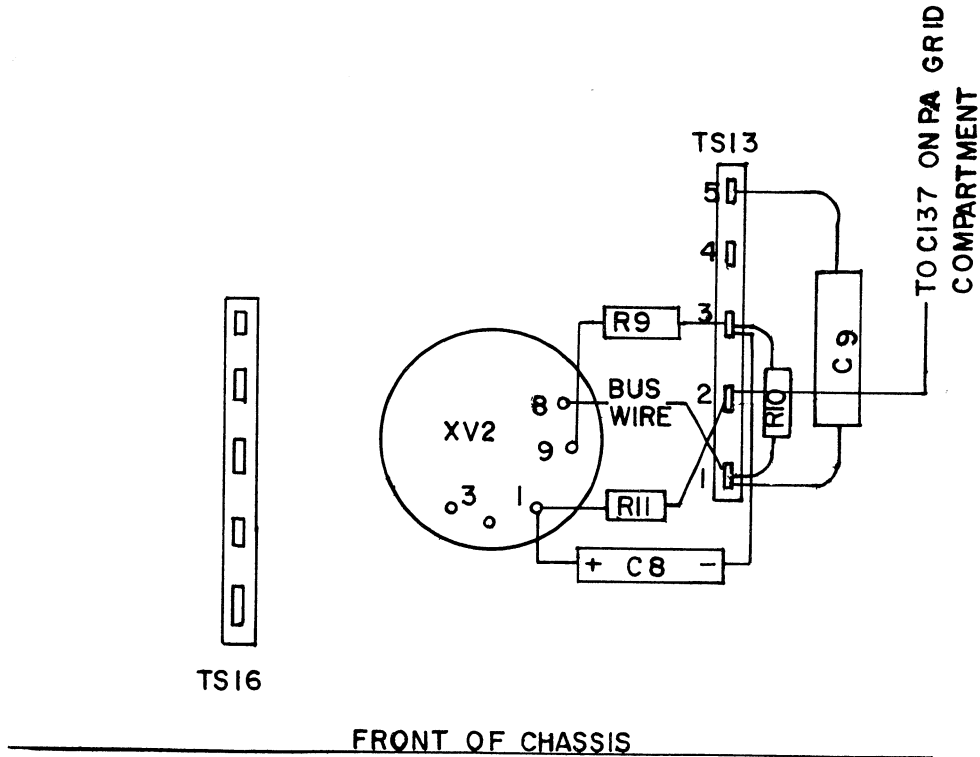
Figure 1. Physical Location of Cathode Follower Components Affected By This Modification.

The modifications described in this service bulletin are to provide improved CW operation of the transmitters. They consist of eliminating the spurious r-f signal that may be transmitted along with the main signal, and eliminating a short carrier "burst" that may occur immediately upon closing of the vox relay.

5. Change C115 from a 0.01- to a 0.05-uf capacitor (913-3679-00). This capacitor is located across the KEY jack on back of unit. (CW waveshape characteristics are affected by this capacitor, and the operator may change its value to suit his preference.)
6. Remove 0.01-uf capacitor C8 which is connected between terminals 3 and 4 of TS13.
7. Remove 180K-ohm resistor R11 which is connected between terminals 2 and 4 of TS13.

8. Remove 15K-ohm resistor R12 which is connected between terminals 2 and 3 of TS13.
9. Remove 220-ohm resistor R10 which is connected between terminals 1 and 2 of TS13.

10. Remove wire which is connected from pin 1 of tube V2 to (+) side of 8-uf dual-section fixed electrolytic capacitor C6A. This capacitor is located adjacent to the BFO TEST.

11. Install new 10K-ohm resistor R11 (745-3394-00) from pin 1 of tube V2 to terminal 2 of TS13.
12. Install new 4-uf capacitor C8 (183-1783-00) from pin 1 of tube V2 to terminal 3 of TS13 with plus (+) lead connected to pin 1. It might be advisable to check if any possibility exists in which the (+) lead might short out to another component, if so, sleeve lead with insulation removed from lead of old C8.

13. Connect no. 22 AWG red (439-7068-00) from terminal 2 of TS13 to feed-through capacitor, C137, on PA grid compartment.
14. Install new 1K-ohm resistor R10* (745-1352-00) between terminals 1 and 3 of TS13.

15. Disconnect lead of 220K-ohm resistor R9 which is connected to terminal 4 of terminal strip TS13 and reconnect to terminal 3 of TS13. (The other end of R9 is connected to pin 9 of V2.)
