**KWM-380 TRANSCEIVER (622-5093-101)
HF-380 TRANSCEIVER (622-3580-101)
RECEIVER-EXCITER CIRCUIT CARD A3 (638-6908-001)**

SERVICE BULLETIN NO 1

PRODUCT IMPROVEMENT

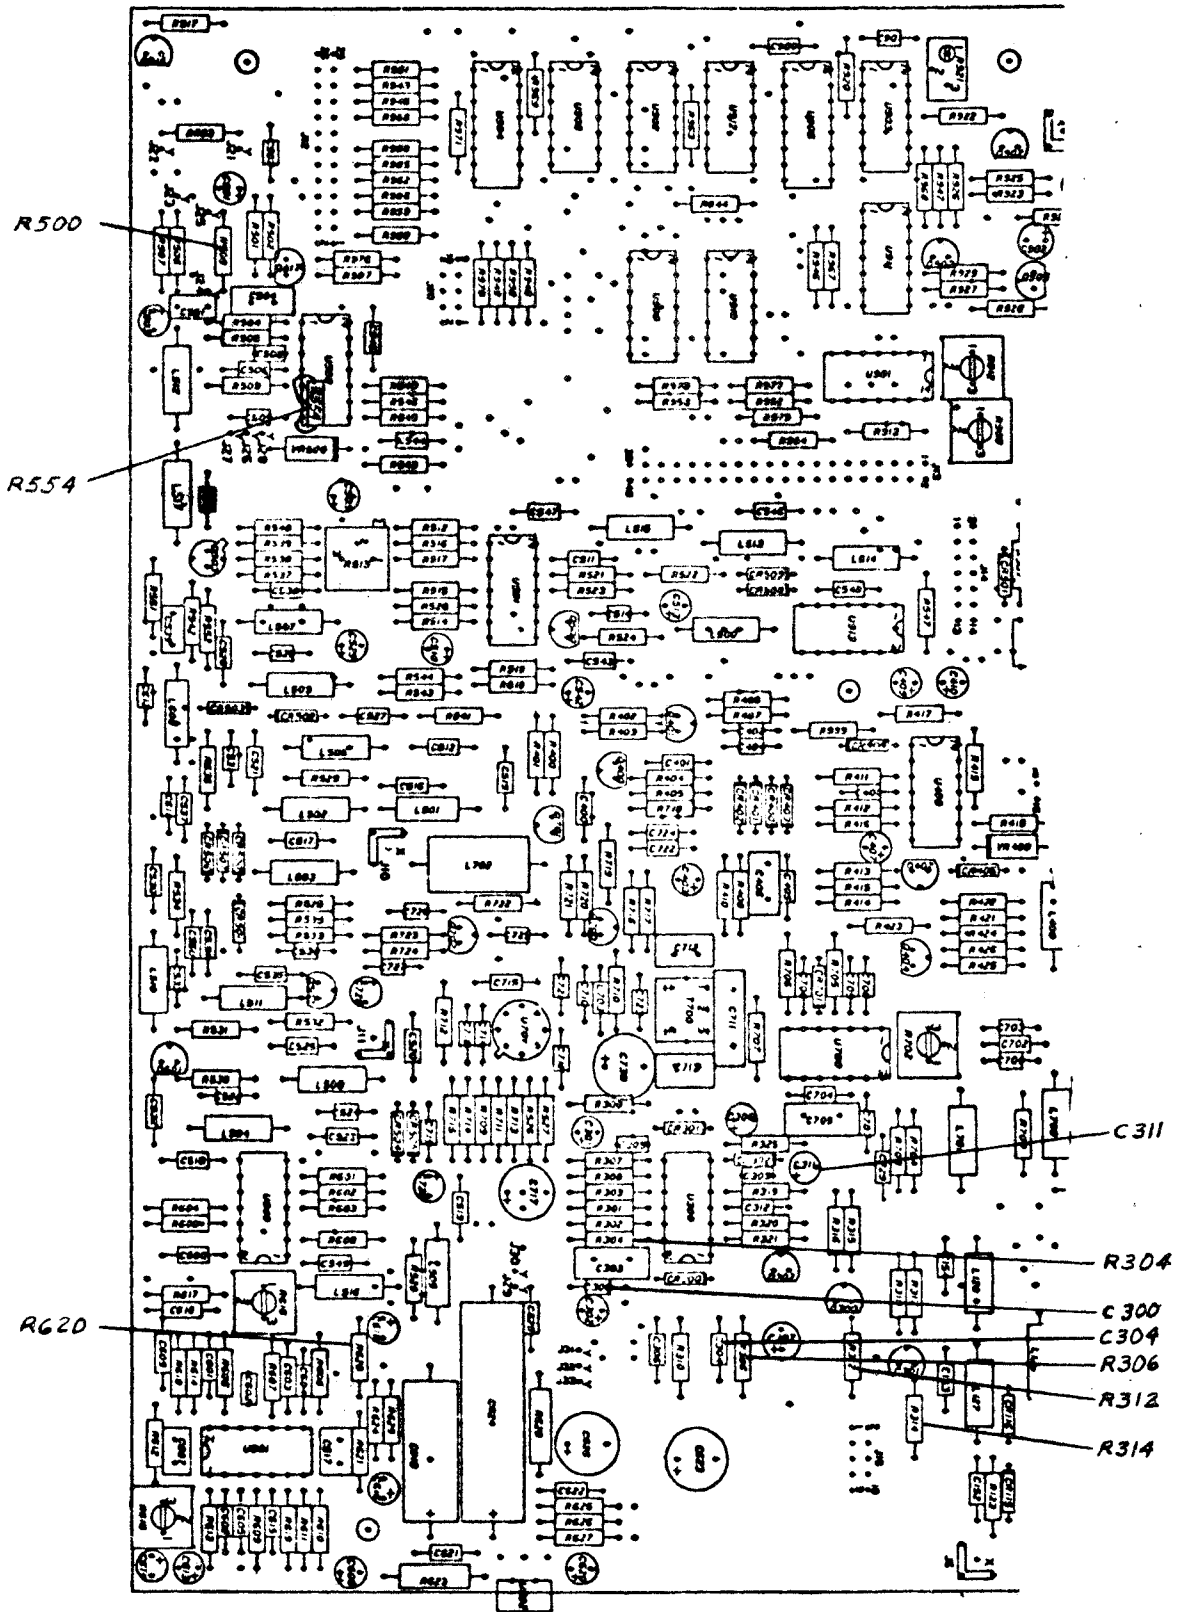
P/O Receiver/Exciter Circuit Card A3
Figure 1

1. Mic termination is changed from 270-Ω to 3.3-k Ω to allow either a low- or high-impedance mic to be used.
2. Mic gain is increased by approximately 18 dB.
3. A greater range of adjustment for VOX sensitivity is provided.
4. Minimum VOX delay time is decreased to less than 50 ms to allow faster semibreak in CW operation.
5. Preemphasis to VOX preamplification is added to improve SSB VOX operation.
6. Line audio (600 Ω) output level is increased to ensure at least -10-dBm output.

All changes are on the receiver-exciter circuit card. The changes consist of replacing 7 resistors and 3 capacitors.

NOTE: All component changes are on the receiver-exciter card A3, located on the bottom of the chassis. Refer to figure 1 for location of components on the receiver-exciter card.

- C. Remove 100-k Ω resistor R554 and replace it with a 1-M Ω resistor (745-2449-000).
- D. Remove 270- Ω resistor R500 and replace it with a 3.3-k Ω resistor (745-0767-000).

- E. Remove 33-k Ω resistor R620 and replace it with an 18-k Ω resistor (745-0794-000).
- F. Remove 1- μ F capacitor C311 and replace it with a 0.22- μ F capacitor (184-9102-310).

- G. Remove 1-M Ω resistor R304 and replace it with a 100-k Ω resistor (745-0821-000).
- H. Remove 0.01- μ F capacitor C300 and replace it with a 1000-pF capacitor (913-3281-270).

- I. Remove 0.1- μ F capacitor C304 and replace it with a 4.7- μ F capacitor (184-9102-390). The negative lead of the capacitor should be connected to the hole on the left.

- J. Remove 1-k Ω resistor R306 and replace it with a 100- Ω resistor (745-0713-000).
- K. Remove 47-k Ω resistors R312 and R314 and replace them with 10-k Ω resistors (745-0785-000).
